VF500 #3  
MARCH 1985

# SERVICE BULLETIN

## 1984/1985 VF500F Frame Drain Hole Drilling

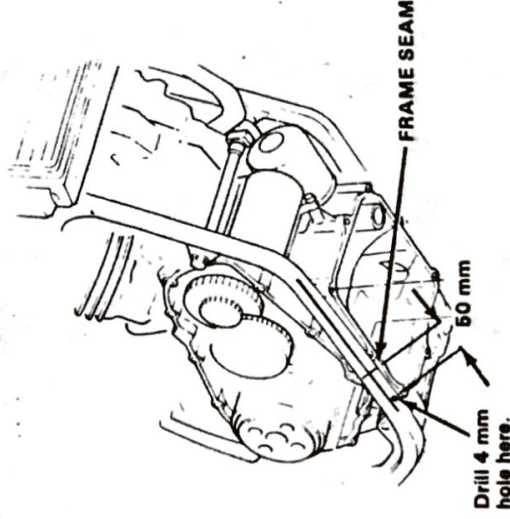
#### Right Side Frame Hole:

Water may enter the frame on some 1984 and 1985 VF500Fs while riding in the rain or washing the motorcycle. If water collects in the lower frame rails, it may freeze and under certain conditions cause the frame to deform. However, this deformation does not affect the handling or safety of the motorcycle.

1. Measure 50 mm behind the frame seam and center punch the underside of the frame as shown.

2. Drill a 4 mm (5/32") hole and paint the bare metal (using a rust-inhibiting paint) to prevent rusting.
